SERVICE BULLETIN

BF93-010

March 9, 1993

MAXIMA - REDUCING SQUEAK AND RATTLE NOISE

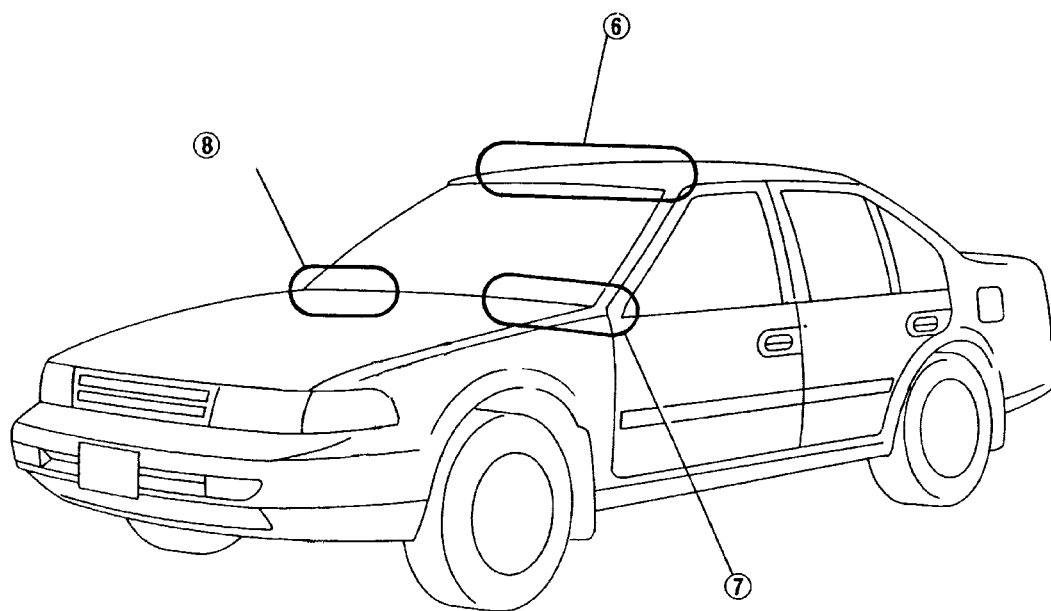
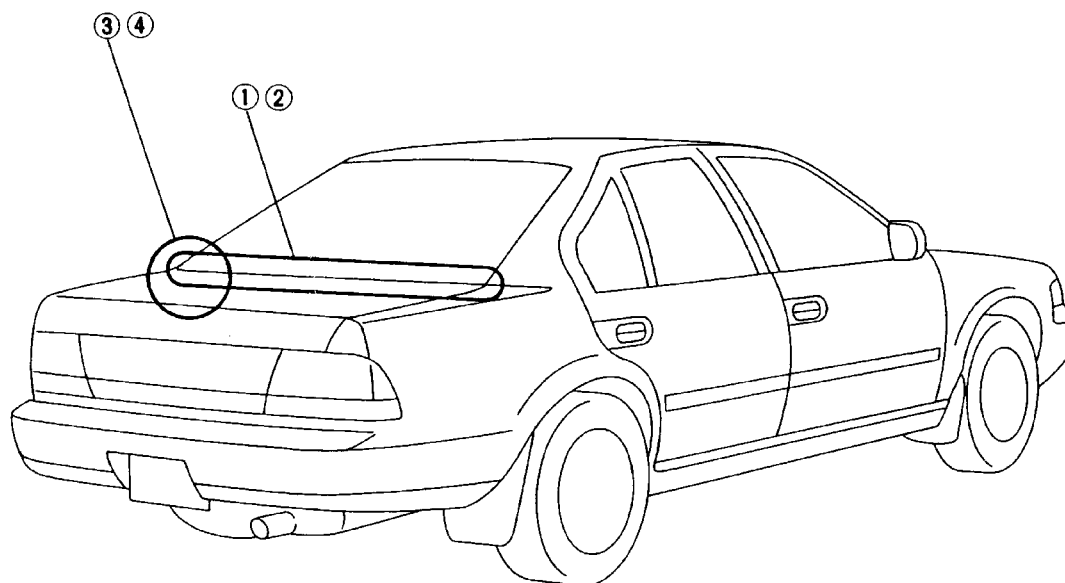
Locations Of Noise

<u>No.</u>	<u>Location of Noise</u>	<u>Condition</u>	<u>Noise Type</u>
1.	Around rear window parcel shelf trim	While driving	Squeak
2.	Around rear parcel shelf trim	While driving	Buzz
3.	Around rear window	While driving	Buzz
4.	Around rear parcel panel	While driving	Click
5.	Roof panel around sun roof	While driving	Creak
6.	Sun roof`	While sun roof glass is operating	Squeak
7.	Instrument panel	While driving	Buzz
8.	Glove box	While driving	Buzz

Numbers preceding noises correspond with those shown in the table on the previous page.

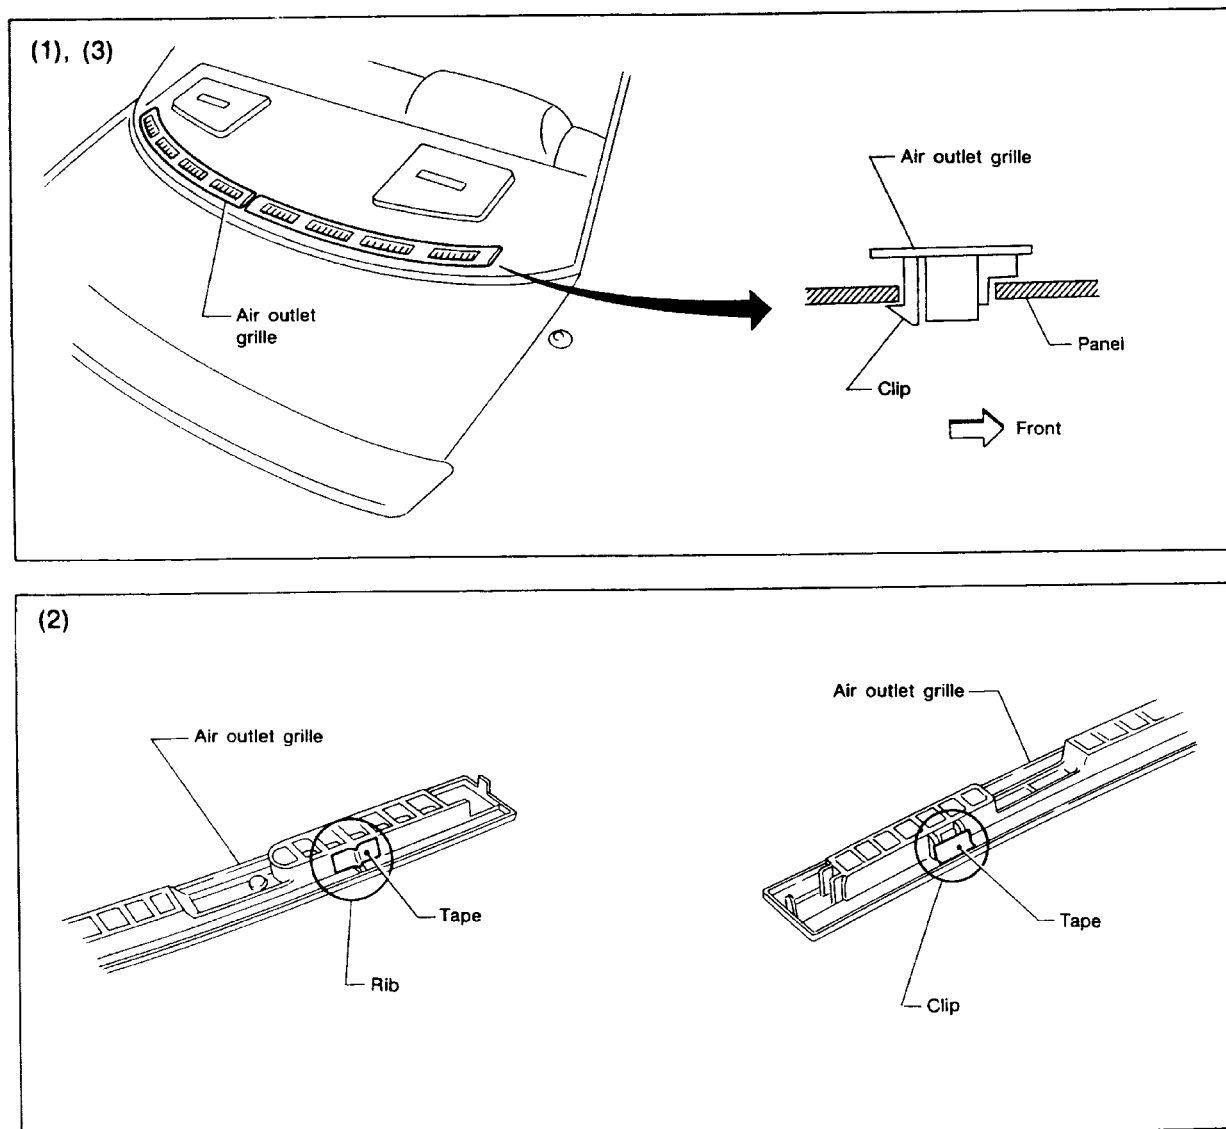
Parts/Location Affected: Rear Air Outlet Grille

SYMPTOM: Squeaking noise develops around the rear window and rear parcel shelf trim while driving.

Method: Using the following procedures, repair the looseness of the air outlet grille with the rear parcel shelf trim and the contact between the air outlet grille and the rear window.

1. Remove the air outlet grille from the rear parcel shelf trim.
2. Apply non-woven cloth tape to the ribs and clips of the air outlet grille.
3. Install the air outlet grille to the rear parcel shelf trim.

NOTE: Make sure that the rear of the air outlet grille is secured.

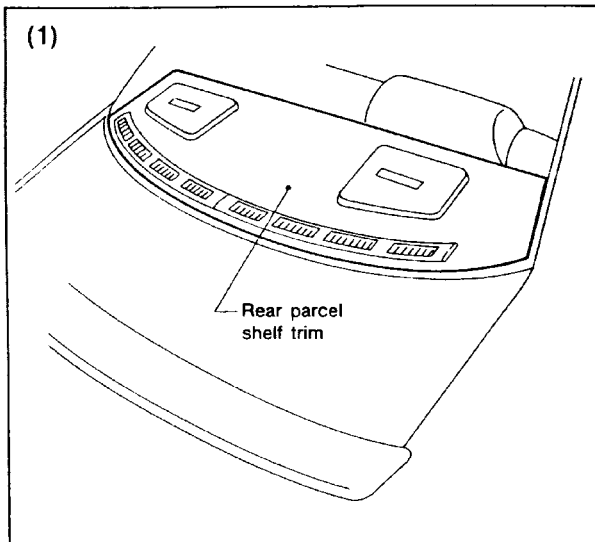
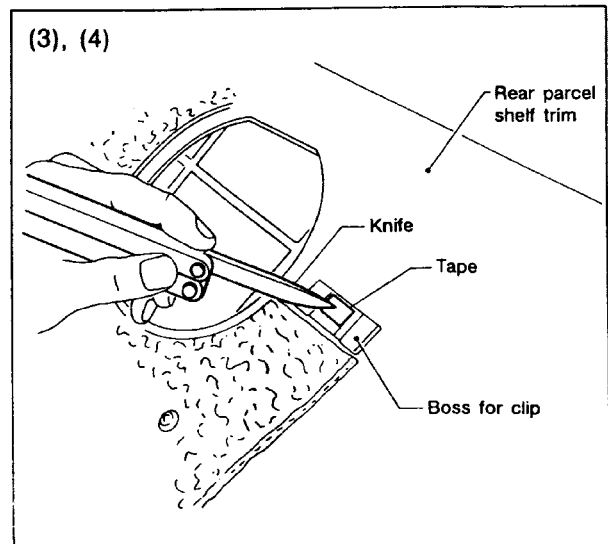
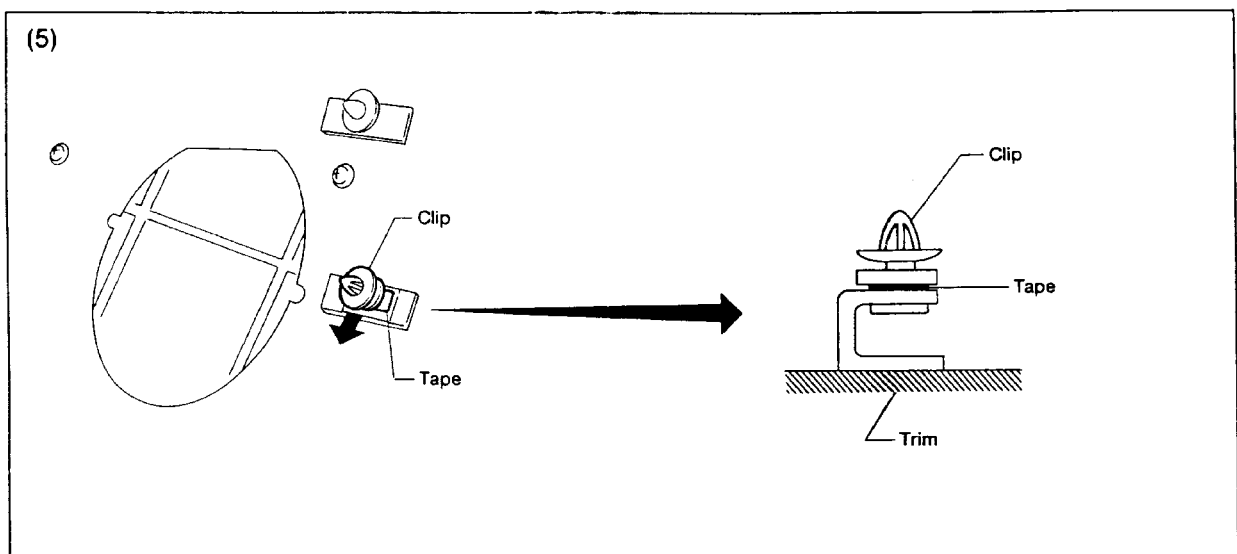
Parts/Location Affected: Rear Parcel Shelf Trim Clip

SYMPTOM: Buzzing noise develops around the rear parcel shelf trim while driving.

1. Remove the rear seat and the rear parcel shelf trim.
2. Remove clips from the rear parcel shelf trim.
3. Apply the non-woven cloth tape on to the clip bosses.
4. Using a knife, cut a hole in the tape for the clip.
5. Install clips on the bosses.
NOTE: Make sure there is no looseness between the clip and the boss.
6. Install the rear parcel shelf trim and the rear seat into the vehicle.

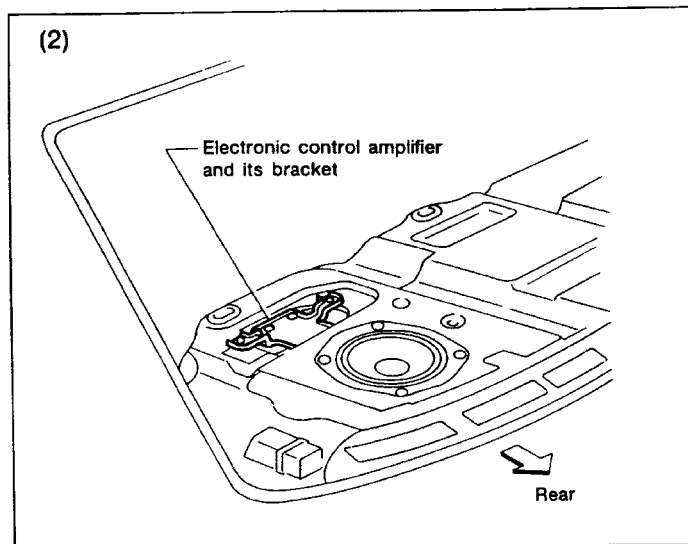
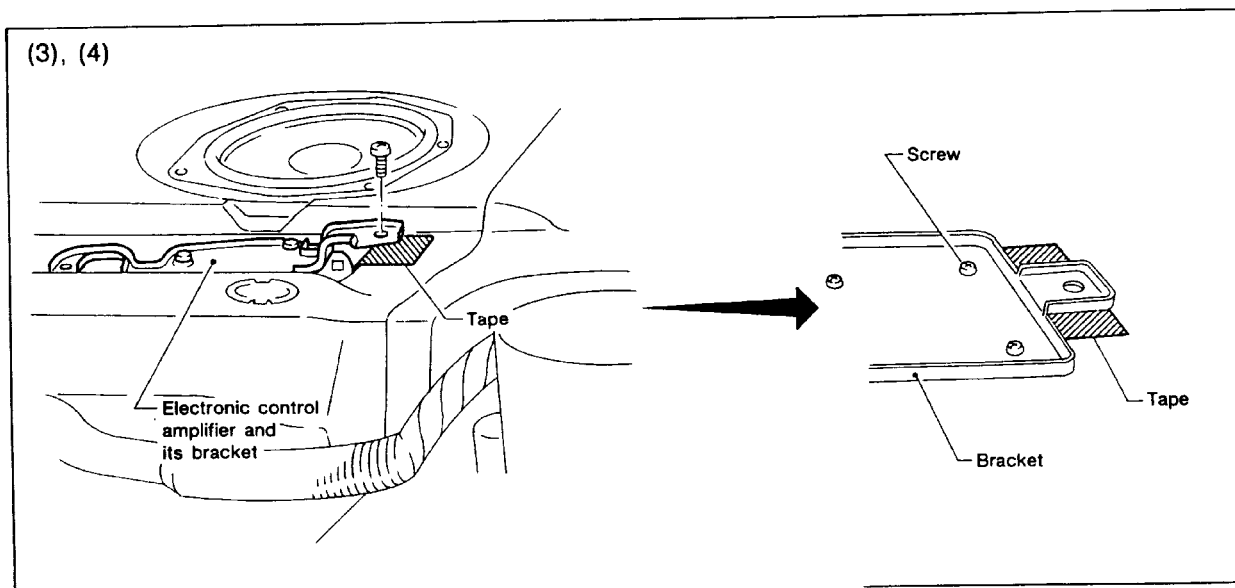
Parts/Location Affected: Electronic Control Stereo Amplifier And Its Bracket

SYMPTOM: Buzzing noise develops around the rear window while driving

1. Remove the rear seat and the rear parcel shelf trim.
2. Remove the electronic control stereo amplifier with its bracket from the rear parcel panel.
3. Tighten down the screws securing the amplifier and its bracket.
4. Apply the non-woven cloth tape to the contact surface between the rear parcel panel and the amplifier bracket.
5. Install the amplifier together with its bracket.
6. Install the rear parcel shelf trim and the rear seat into the vehicle.

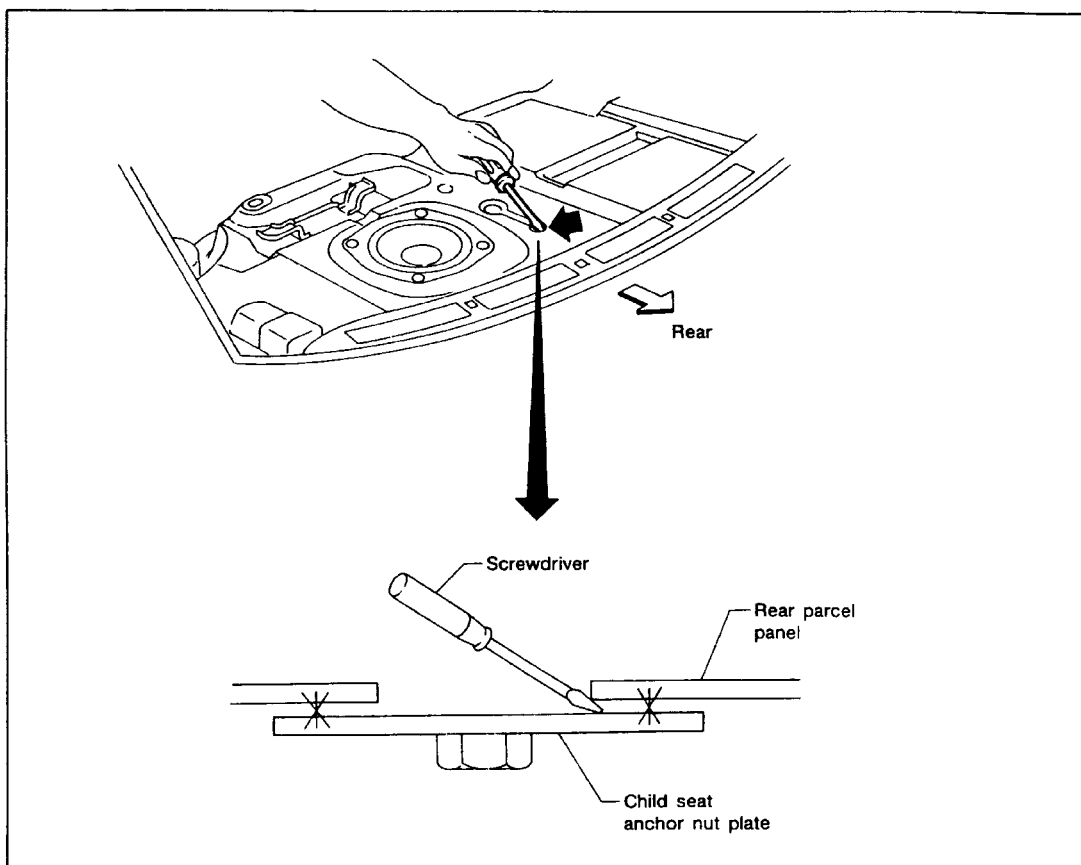
Parts/Location Affected: Child Seat Anchor Nut Plate And Rear Parcel Panel

SYMPTOM: Clicking noise develops in the vicinity of the rear panel while driving.

1. Remove the rear seat and the rear parcel shelf trim.
2. Insert a screwdriver between the child seat anchor nut plate and the rear panel; twist the rear parcel panel with the screwdriver.

NOTE: Do not deform the panel.

3. Install the rear panel shelf trim and the rear seat into the vehicle.

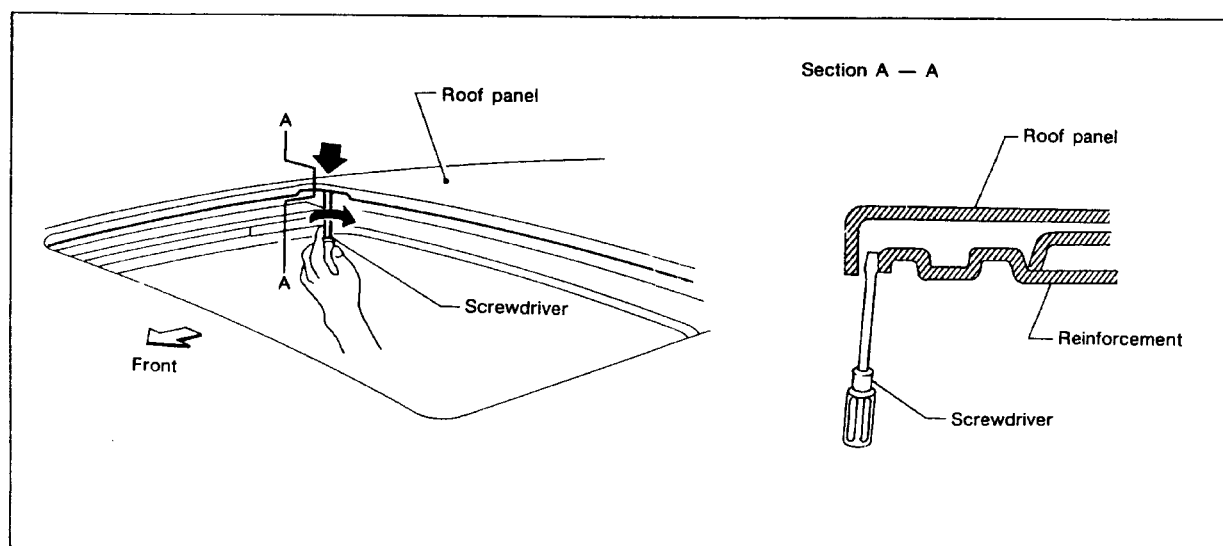
Parts/Location Affected: Roof Panel Around Sun Roof

SYMPTOM: Creaking noise develops, while driving, from the roof panel around the sunroof.

1. Remove the sunroof glass from the vehicle.
2. Insert a screwdriver between the roof panel and body reinforcement; twist the screwdriver a little at both sides of the sunroof.

NOTE: Be careful not to damage the roof panel.

3. Install the sunroof glass.

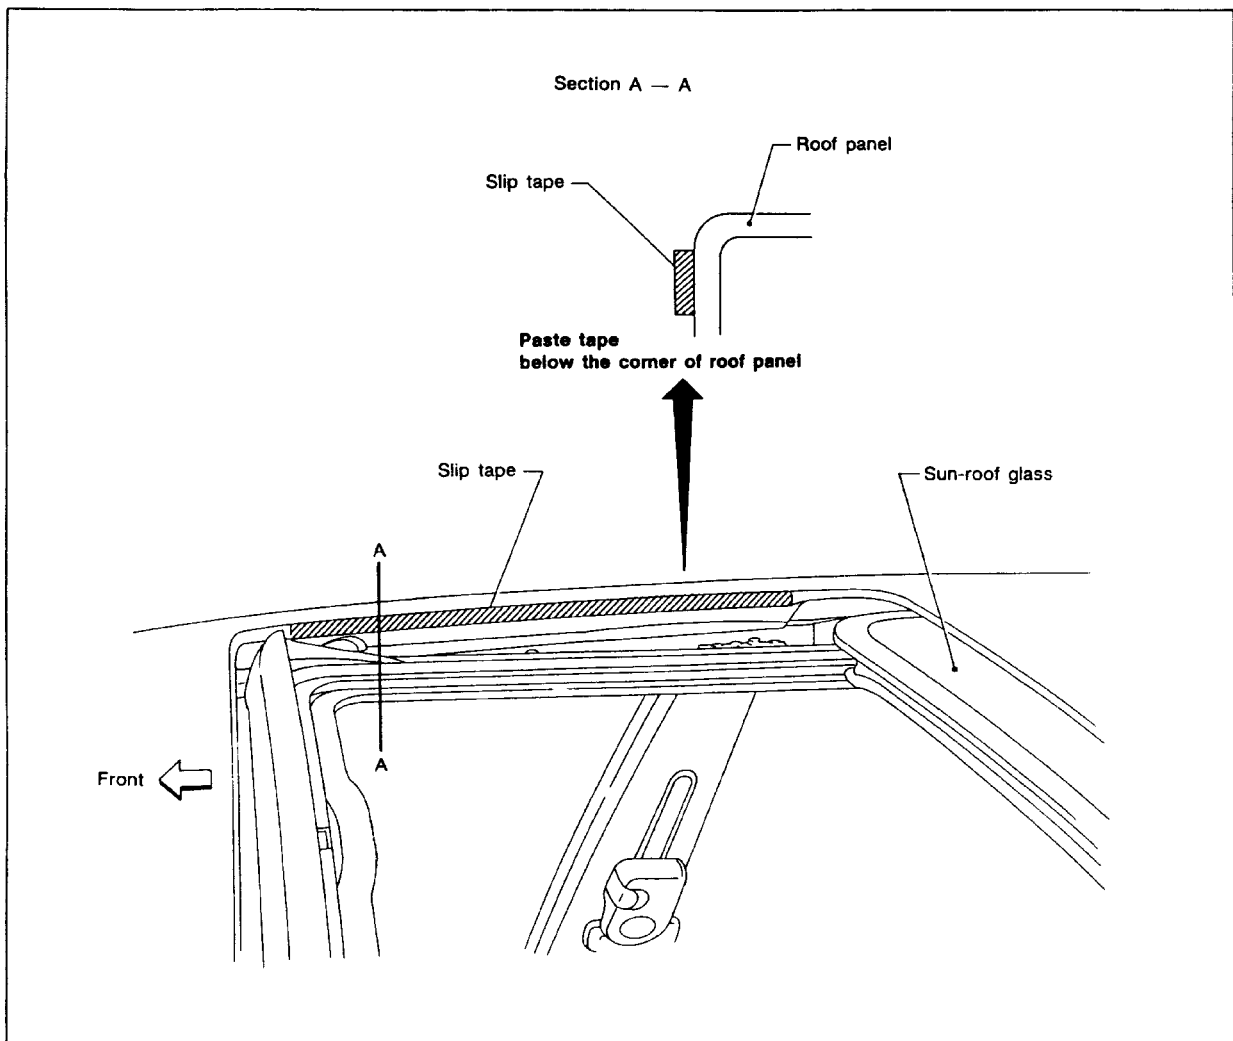
Parts/Location Affected: Sun Roof Glass Weatherstrip

SYMPTOM: While the sunroof is opening or closing, a squeaking noise develops between the sun roof glass weatherstrip and the roof panel.

1. Open the sunroof fully.
2. Apply 3M Squeak Reduction Tape, P/N 5430 or equivalent, to the contact surface between the roof panel and sunroof glass weatherstrip - as illustrated below.

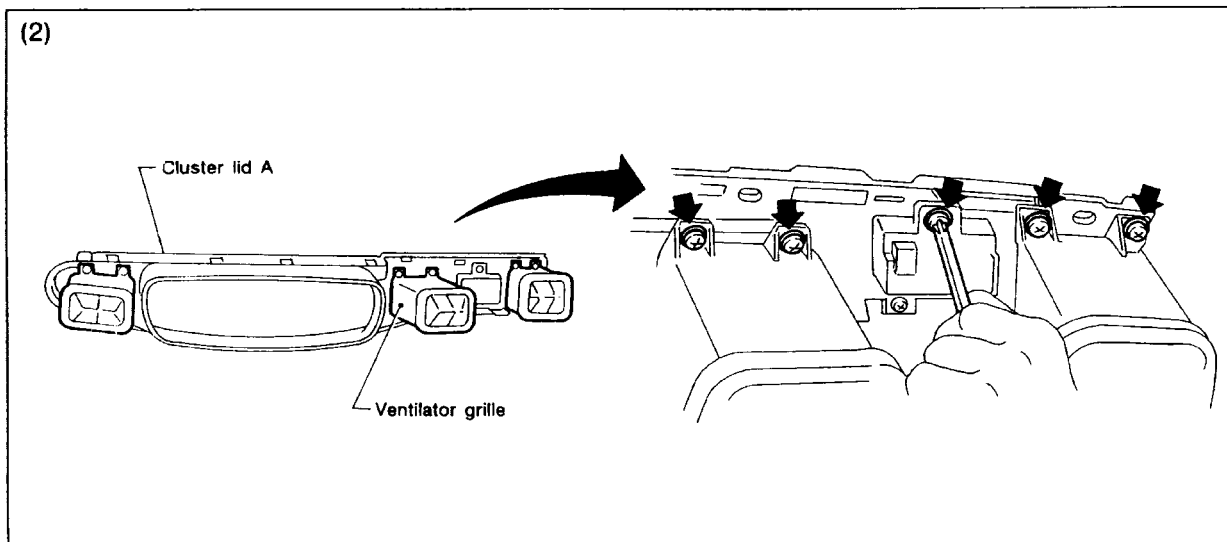
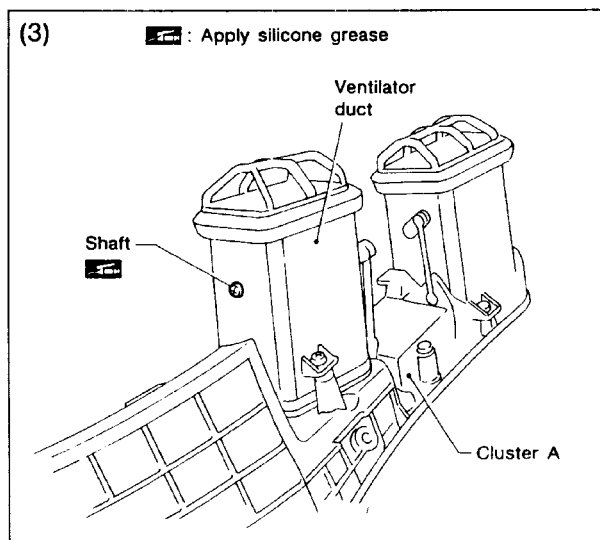
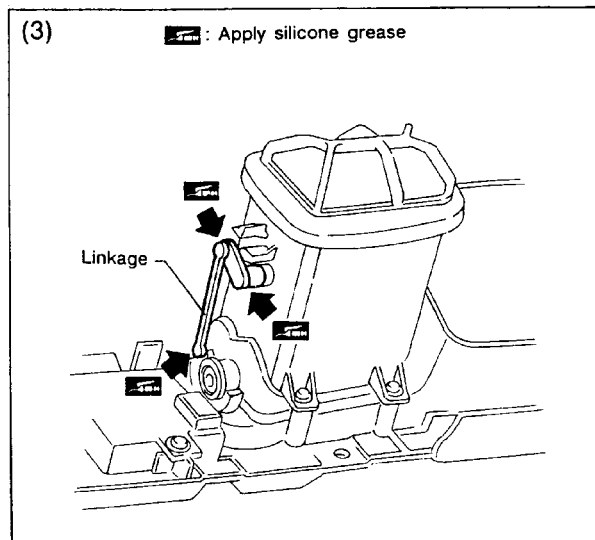
Parts/Location Affected: Meter Cluster And Ventilator Duct

SYMPTOM: Buzzing noise develops around the instrument panel while driving.

Repair the looseness of the ventilator ducts and their shut valve linkages according to the following procedures.

1. Remove the steering column cover, lower instrument cover, switch panel, and cluster lid "A".
2. Tighten screws securing cluster lid "A" and the ventilator duct.
3. Apply silicone grease to the ventilator shut valve linkages and the shafts [inside and outside of the shafts].
4. Install any parts removed.

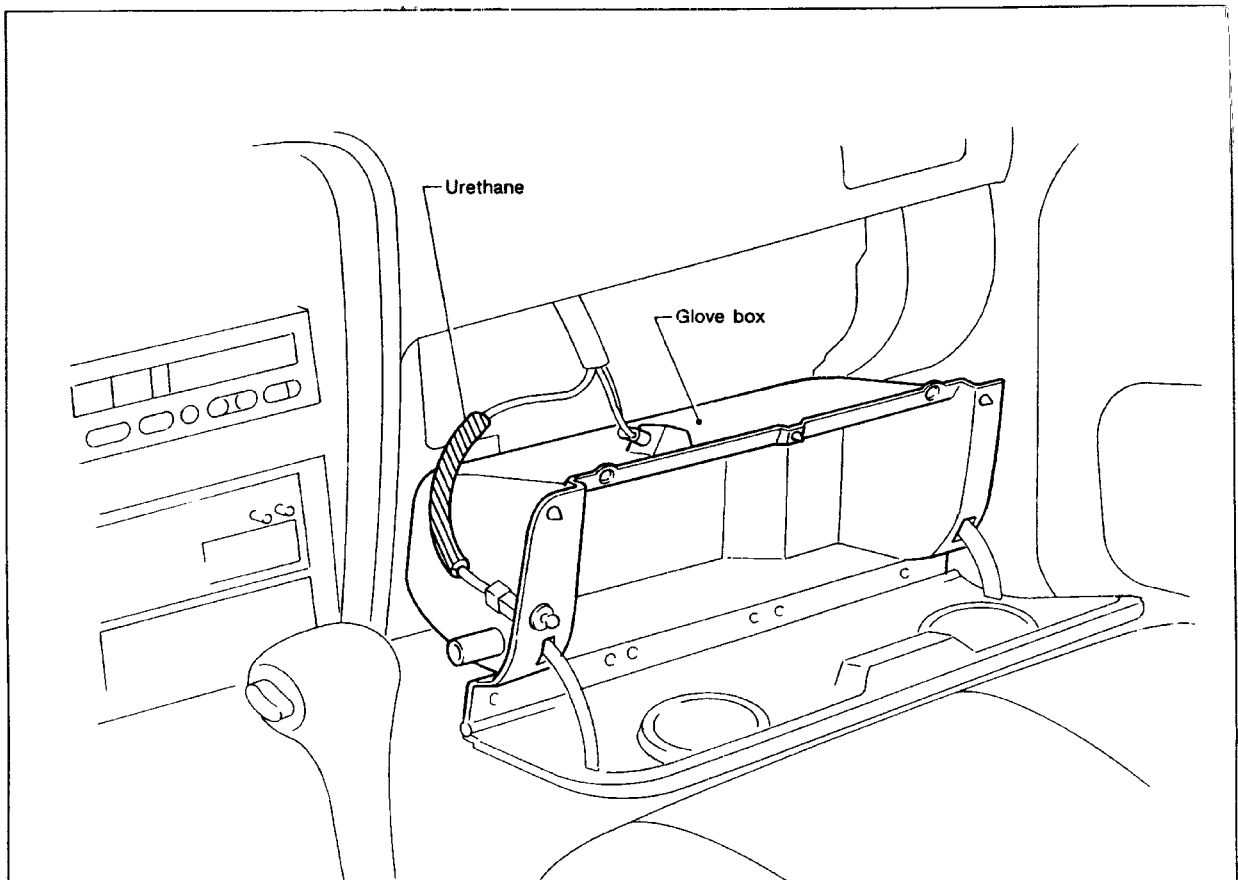
Parts/Location Affected: Glove Box

SYMPTOM: A buzzing noise develops in the vicinity of the glove box while driving

Wrap the electrical harness for the glove box lamp with Foam Tape to insulate the harness from contact with the glove box.

1. Remove the glove box from the instrument panel.
2. Wrap 3M 1/4" Black Vinyl Foam Tape, P/N 051131-06370 or equivalent around the part of the harness that contacts the glove box.
3. Install the glove box into the instrument panel.
